Back-Seat Problem Volvo V70 (2000-2007)

Problem with the back of backseat which cannot be felt down. Problem med baksäte Volvo

This information is for the RIGHT HANDSIDE (The large part of the seat).

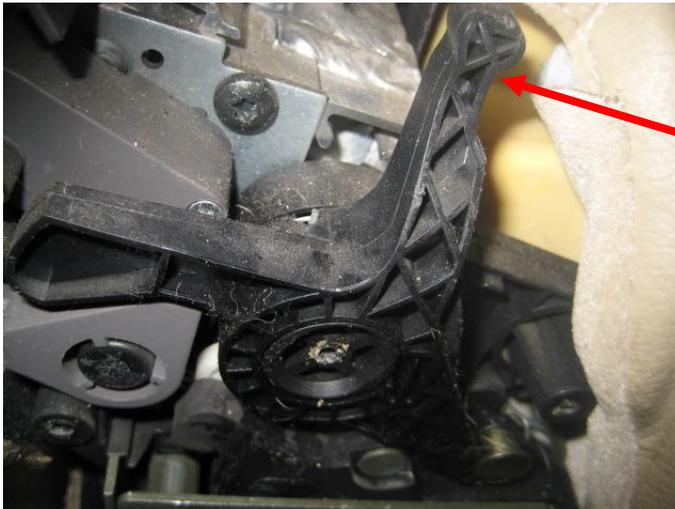
Between the plastic and the clothing you just put in a screw driver and at the same time you operate the normal push bottom switch you push the driver towards the metal arm showing in the picture.

Push the screw driver in the same angel as the arrow shows and at the same time use the original push switch.

First push the original push bottom then the arm showing in the picture and it has to go far back to the end else it will only open half way.

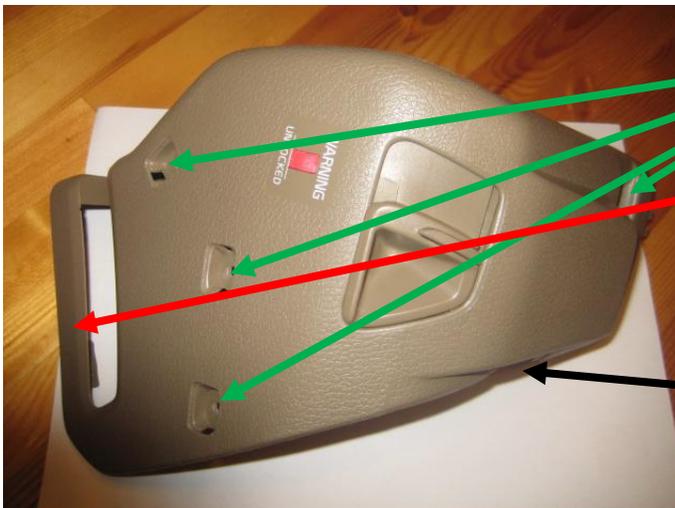
Then you take off the plastic cover from the seat. 4 plastic covers and 4 torx screws.

Take of the cover and take out the torx screws.

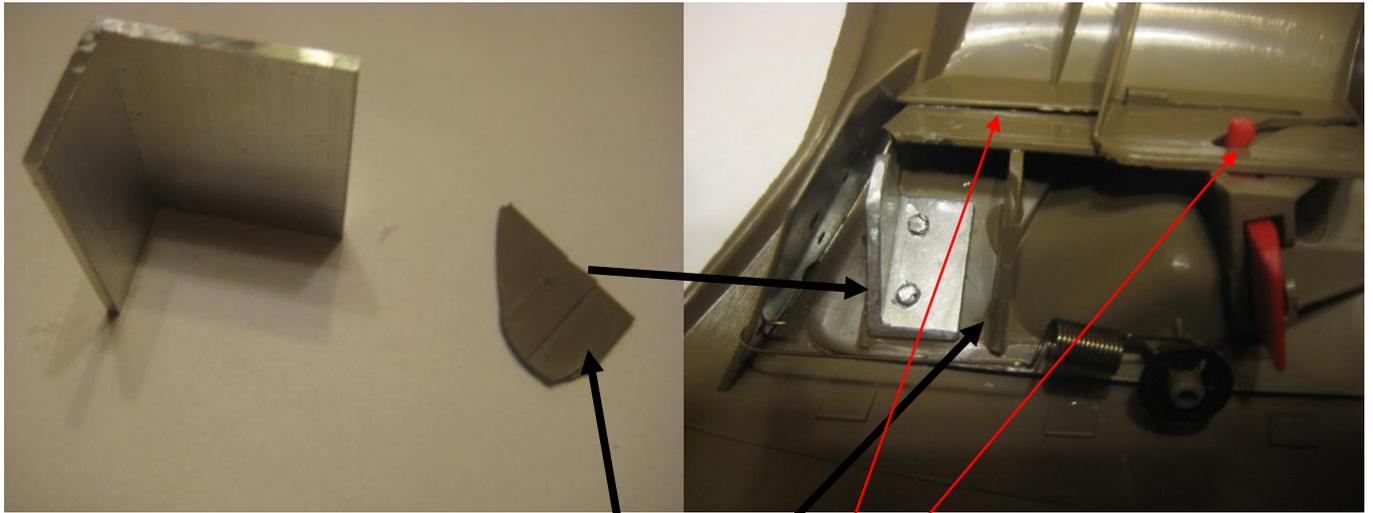
Now we can see the metal arm and if you take a closer look it is probably one plastic part that is broken. If not then there is something else and then this maybe will not help you.

We used an aluminum angel size: 30x20x2mm which we modified to fit.

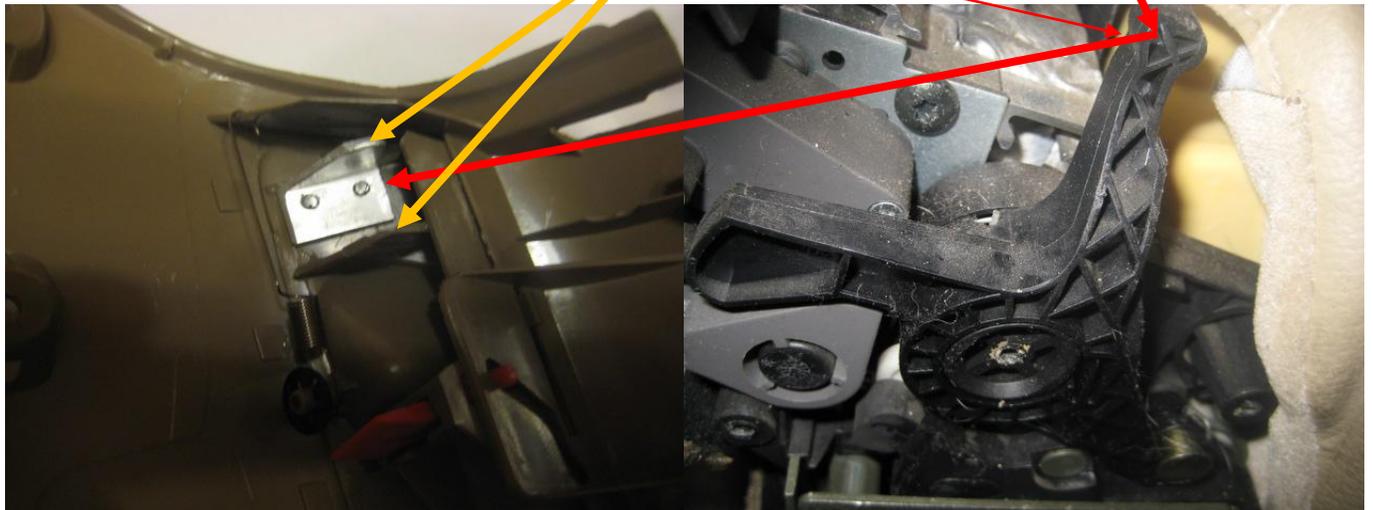
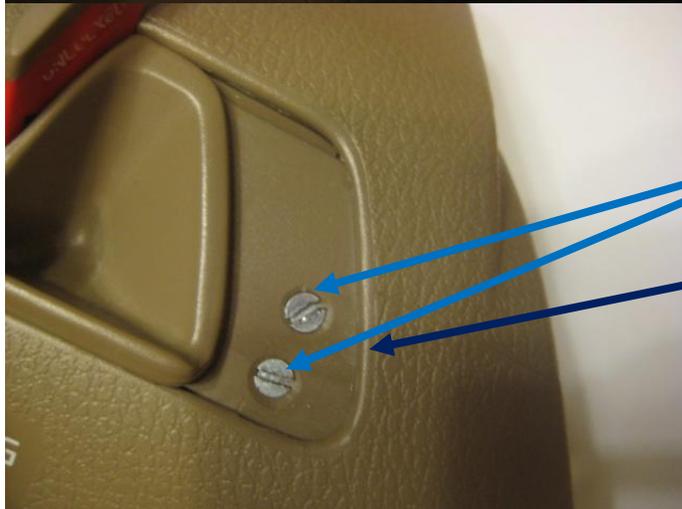
This plastic was in our car broken and the arm is going between this 2 plastic walls. We replaced it with an aluminum angel which we modified to fit as the picture shows.
Some Vaseline is good on this place.

The aluminum angel was fastening with 2 M3 screws as the picture shows. You have to make the hole according to the drawings further down else it will not pas under the other plastic.
We used 10mm long M3 screw, which we cut the length so the screws come out 0,5mm in the back. If it is to long the screws will be going into the arm and it will not work.

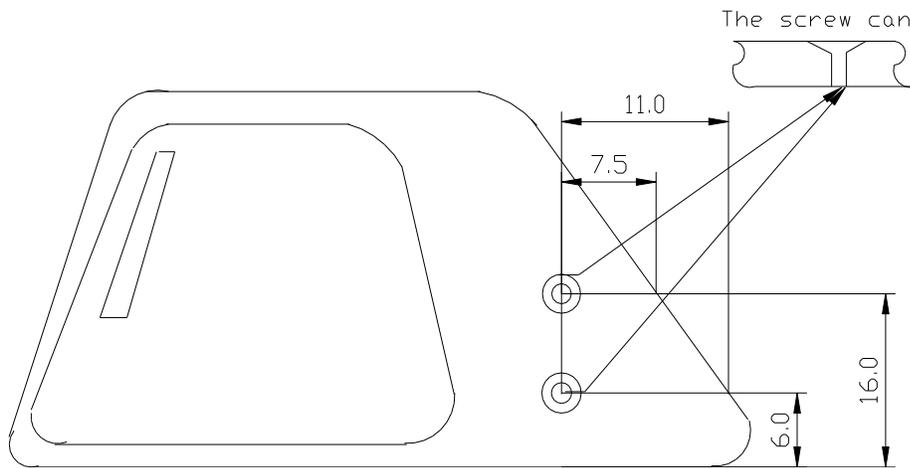
When you drill the holes you have to have the push bottom pushed open.

Be sure the screws are in the same level as the bottom plastic.

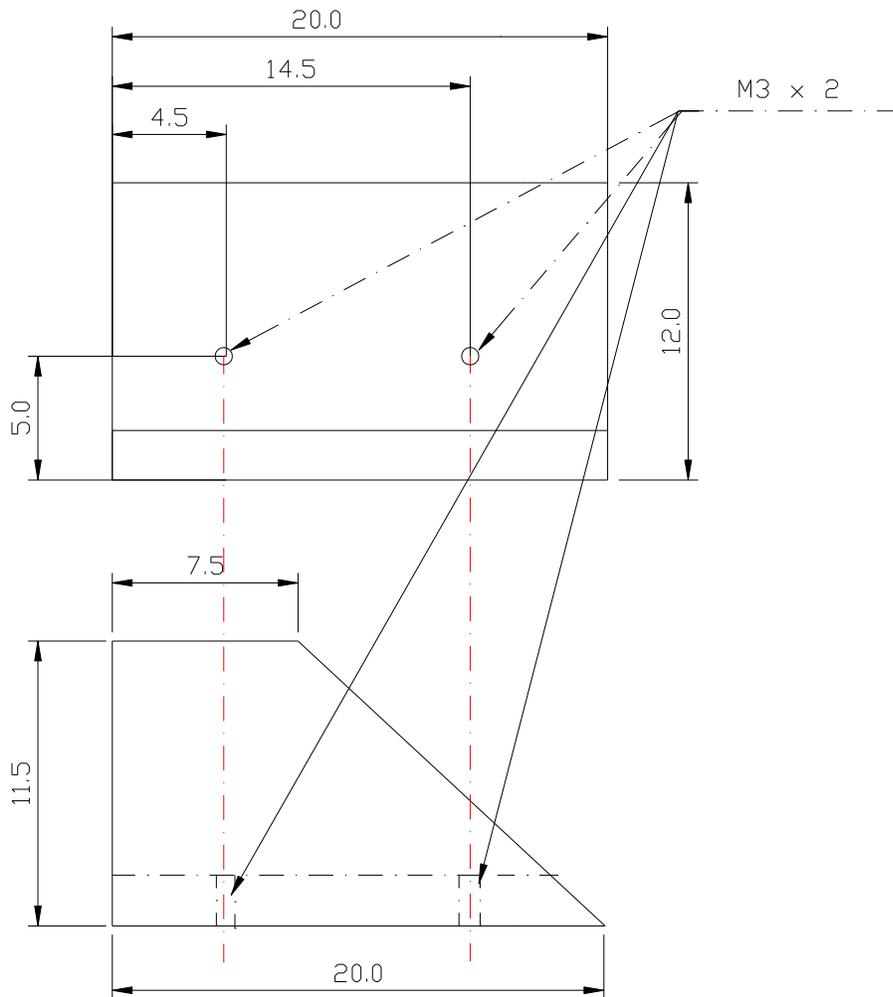
Drawing of the modified aluminum angel 30x20x2mm.

All measurement in mm

For the left hand seat you must make the angle reversed. (Mirrored)
